**Flood Control Project Maintenance  
Levee Inspections**

## Maintenance Issue Types Only, Levee Inspection Report By Mile - Spring 2019

### Reclamation District No. 0563 Tyler Island

Waterway	Bank	Unit Miles	Inspection Start/End	Inspector
Unit No. 01 Georgiana Slough (Tyler Island)	Left	12.11	04/05/2019 04/05/2019	David Julian

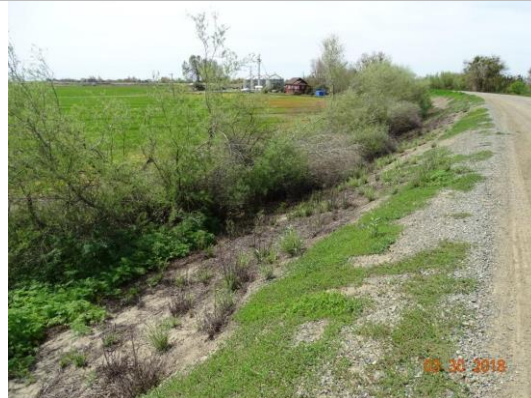
Photo 1 of 1 : SP\_2019\_RD0563\_210\_112\_20190311\_00078.jpg

LM Start	3.11	Rating **	U	Issue No.	112
LM End	3.21	Issue Type +	Ma	Location *	LS
Category	Earthen Levee			GPS Latitude/Longitude	
				Start	End
Item	Vegetation			38.210018 °	38.209201 °
				-121.538353 °	-121.539871 °
DWR ID	DWR_RD0563_01_s_2018_112				
Comment Code					
V7 : Trees / Woody Vegetation					
Inspector Comment					
Dense woody vegetation (up to 6" in diameter) along lower slope and toe prevents inspection and access. Needs to be removed.

Very dense woody vegetation preventing inspection and access to landside toe.

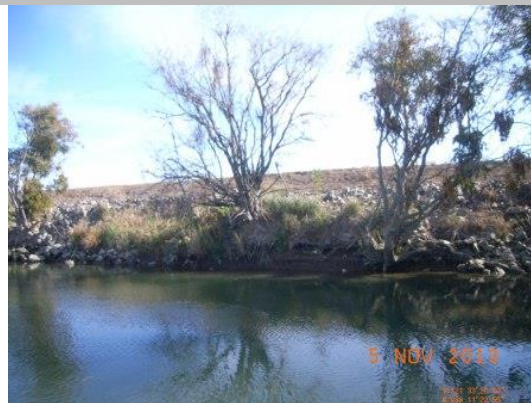
Photo 1 of 1 : SP\_2019\_RD0563\_210\_94\_20190311\_00065.jpg

LM Start	3.42	Rating **	M	Issue No.	94
LM End	4.01	Issue Type +	Ma	Location *	WS
Category	Supplemental			GPS Latitude/Longitude	
				Start	End
Item	2017 USACE Erosion Survey, DRAFT			38.206346 °	38.199925 °
				-121.540819 °	-121.544249 °
DWR ID	DWR_RD0563_01_f_2018_94				
Comment Code					
Inspector Comment					
2017 Site ID: GEO 8.3 L					
Status: Eroding					
2017 Field Notes: New rock on levee in sections, failure of old rock in other sections, site extended upstream to account for new erosion pocket.					
Site History: 1997 - Narrow eroding berm upstream of existing rock.					
2001 - Staked, low fascine walls at bankline. 2011 - Minor new erosion. Site extended downstream. 2012 - Rock repair failing in one erosion pocket. 2016 - Fresh erosion observed.

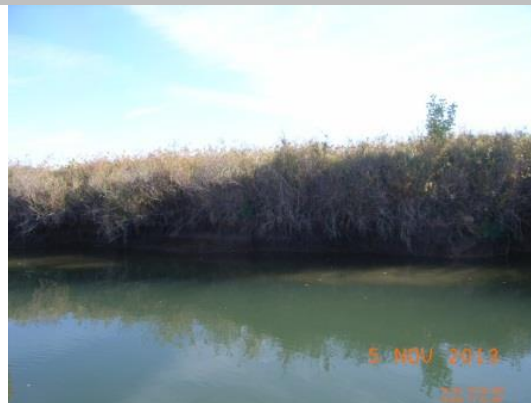
Photo 1 of 1 : SP\_2019\_RD0563\_210\_92\_20190311\_00063.jpg

LM Start	4.98	Rating **	M	Issue No.	92
LM End	5.04	Issue Type +	Ma	Location *	WS
Category	Supplemental			GPS Latitude/Longitude	
				Start	End
Item	2017 USACE Erosion Survey, DRAFT			38.190073 °	38.189524 °
				-121.556307 °	-121.557227 °
DWR ID	DWR_RD0563_01_f_2018_92				
Comment Code					
Inspector Comment					
2017 Site ID: GEO 7.2 L					
Status: Eroding					
2017 Field Notes: New erosion at toe.					
Site History: 2009 - Small scallops of erosion into the levee toe behind brush boxes. 2011 - Minor new erosion. 2012 - Site extended upstream to account for addition erosion pockets. 2016 - Fresh erosion observed.

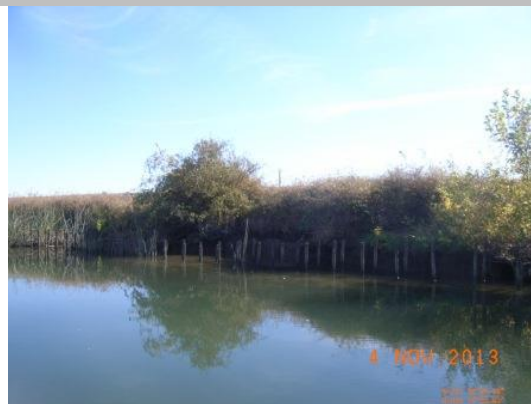
Photo 1 of 1 : SP\_2019\_RD0563\_210\_91\_20190311\_00062.jpg

LM Start	5.39	Rating **	U	Issue No.	91
LM End	5.39	Issue Type +	Ma	Location *	WS
Category	Supplemental			GPS Latitude/Longitude	
				Start	End
Item	2017 USACE Erosion Survey, DRAFT			38.186013 °	38.185968 °
				-121.561512 °	-121.561667 °
DWR ID	DWR_RD0563_01_f_2018_91

Comment Code					
Inspector Comment					
2017 Site ID: GEO 6.3 L					
Status: Critical					
2018: Do not see evidence of vertical face erosion from levee hinge.					
2017 Field Notes: Upgraded to CRITICAL. Combined with 6.8. Vertical sections from mid slope to toe, vertical face from levee hinge at some locations. Wave/tide erosion at toe, evidence of beavers.					
Site History: 1997 - Deep pockets of erosion and narrow berm. Reach is characterized by lots of pockets into the existing berm and/or levee slope. 1999 - Some pockets filled with rock riprap. 2000 - Exposed fabric. 2001 - Staked, low fascine walls at bankline. 2002 - New spot of rock at upstream end. Some new brush boxes. 2005 - Some stone sliding off the underlying geotextile fabric. Some new brush bundles in the brush boxes; some with missing bundles. Some boxes too low relative to high tide. 2009 - Minimal new erosion, site length extended. 2010 - New erosion on downstream end, site extended downstream. 2011 - Sites 6.1, 6.4 and 6.6 were combined. New erosion pockets, site extended to include the erosion in between the old sites. 2012 - Rock has been placed in portions of the bank since last year. 2016 - Site 5.8 was merged with this site due to new erosion connecting the sites.

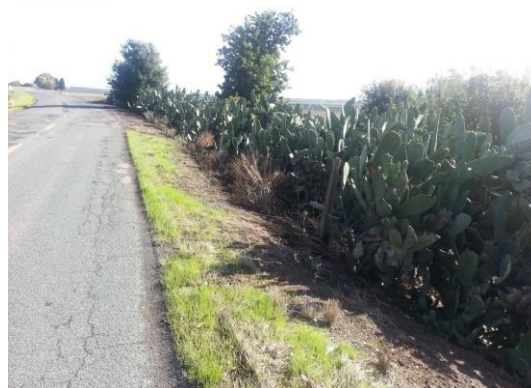
Photo 1 of 1 : SP\_2019\_RD0563\_210\_22\_20190311\_00011.jpg

LM Start	5.92	Rating **	U	Issue No.	22
LM End	5.96	Issue Type +	Ma	Location *	LS
Category	Earthen Levee			GPS Latitude/Longitude	
				Start	End
Item	Vegetation			38.181965 °	38.181763 °
				-121.569913 °	-121.570447 °
DWR ID	DWR_RD0563_01_s_2012_22				
Comment Code					
V2 : Remove the wild growth other than native grasses from the levee slopes.					
Inspector Comment					
Large cactus on landside slope.

Looking downstream at dense cactus on landward slope. (Fall 2016)

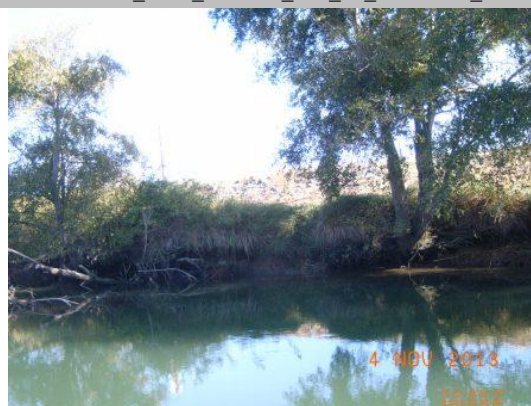
Photo 1 of 1 : SP\_2019\_RD0563\_210\_85\_20190311\_00055.jpg

Comment Code					
Inspector Comment					
2017 Site ID: GEO 4.5 L Status: Critical 2018: Erosion happening at berm, 15 to 20' from the levee hinge point from the berm in some places, erosion into levee toe at other spots (Djulian). 2017 Field Notes: Numerous areas of bank erosion, with vertical sections up to the levee hinge. Site History: 1997 - Pocket erosion at upstream end and into the levee toe under the Alder trees. 2003 - New brush boxes with wattles on bank. 2004 - No brush boxes. 2005 - Site extended from the downstream side of the bridge. Whole bank is vertical. 2010 - Some minor new erosion. 2011 - Site upgraded to CRITICAL. New erosion pockets throughout the site. Sites 4.5, and 4.6 were combined. 2016 - Fresh erosion observed.

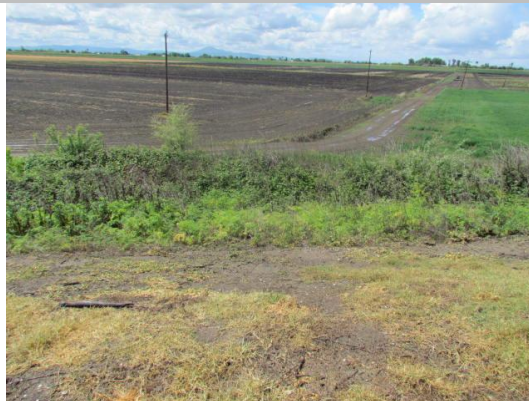
Photo 1 of 1 : SP\_2019\_RD0563\_210\_769\_20190311\_00123.jpg

LM Start	9.36	Rating **	M	Issue No.	769
LM End	9.43	Issue Type +	Ma	Location *	LS
Category	Earthen Levee			GPS Latitude/Longitude	
				Start	End
Item	Vegetation			38.146276 °	38.147034 °
				-121.590189 °	-121.590907 °
DWR ID	DWR_RD0563_01_s_2015_769				
Comment Code					
V2 : Remove the wild growth other than native grasses from the levee slopes.					
Inspector Comment

Looking east at dense vegetation at landward toe. (Spring 2015)

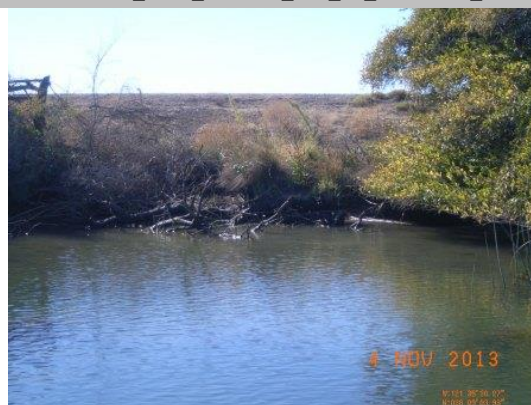
Photo 1 of 1 : SP\_2019\_RD0563\_210\_82\_20190311\_00052.jpg

LM Start	9.73	Rating **	A/W	Issue No.	82
LM End	9.90	Issue Type +	Ma	Location *	WS
Category	Supplemental			GPS Latitude/Longitude	
				Start	End
Item	2017 USACE Erosion Survey, DRAFT			38.150820 °	38.150647 °
				-121.593650 °	-121.596858 °
DWR ID	DWR_RD0563_01_f_2018_82				
Comment Code					
Inspector Comment					
2017 Site ID: GEO 2.5 L Status: Eroding 2017 Field Notes: Head scarp observed. Site History: 1997 - Erosion pockets into the toe of the levee. 2001 - Staked low fascine walls at the bankline. 2004 - Numerous "Brush Boxes." 2005 - Some new bundles in the brush boxes. 2012 - Site extended downstream to account for new bank sloughing. 2013 - Some rock added to the upstream end by the local RD.

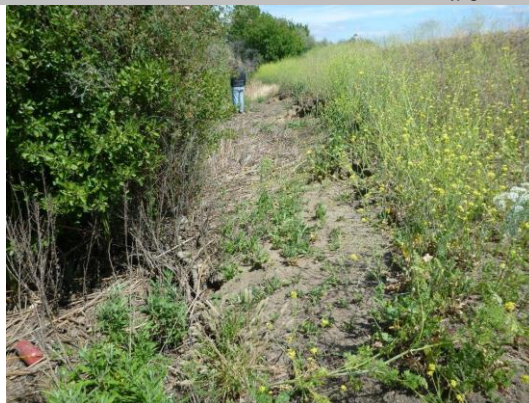
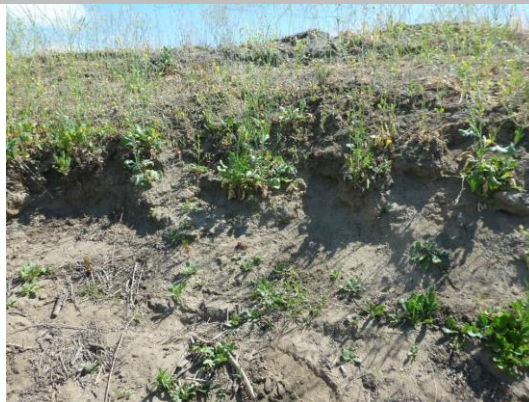
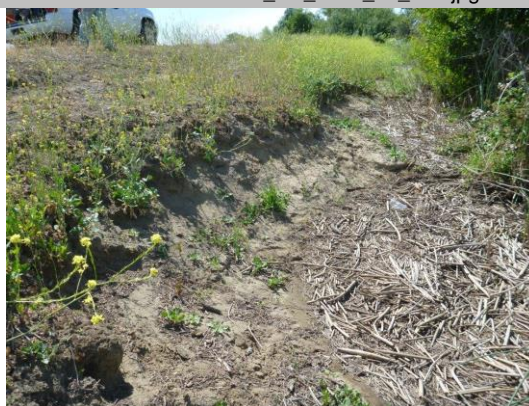
LM Start	9.73	Rating **	A/W	Issue No.	105	
LM End	9.78	Issue Type +	Ma	Location *		
Category	Supplemental			GPS Latitude/Longitude		
				Start		End
Item	2017 Storm Damage			38.150820 °		38.151196 °
				-121.593650 °		-121.594780 °
DWR ID	DWR_RD0563_01_s_2018_105					
Comment Code						
Inspector Comment						
Levee Evaluation Comments						
Description:						
Site ID No:70						
Site Designation:DWR_RD0563_01_s_2012_49						
Repair Type: Erosion						
Rating:Serious						
Field Date:6/9/2017						
Notes:

LM Start	9.73	Rating **	A/W	Issue No.	105 (cont)	
LM End	9.78	Issue Type +	Ma	Location *		
Category	Supplemental			GPS Latitude/Longitude		
				Start	End	
Item	2017 Storm Damage			38.150820 °	38.151196 °	
				-121.593650 °	-121.594780 °	
DWR ID	DWR_RD0563_01_s_2018_105					
Comment Code						
Inspector Comment						
Levee Evaluation Comments						
Description:						
Site ID No:70						
Site Designation:DWR_RD0563_01_s_2012_49						
Repair Type: Erosion						
Rating:Serious						
Field Date:6/9/2017						
Notes:

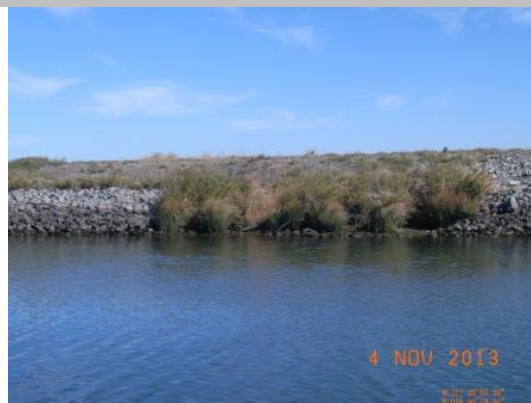
Photo 1 of 1 : SP\_2019\_RD0563\_210\_65\_20190311\_00024.jpg

LM Start	10.45	Rating **	M	Issue No.	65
LM End	10.74	Issue Type +	Ma	Location *	WS
Category	Supplemental			GPS Latitude/Longitude	
				Start	End
Item	2017 USACE Erosion Survey, DRAFT			38.143519 °	38.139918 °
				-121.599677 °	-121.596986 °
DWR ID	DWR_RD0563_01_f_2018_65				
Comment Code					
Inspector Comment					
2017 Site ID: GEO 1.7 L Status: Eroding 2017 Field Notes: New rock placed in erosion pockets, site has improved with work done by RD, but still some erosion pockets and toe erosion. Slump failure with headscarp at downstream end. Site History: 1997 - Old damaged rock riprap along the toe. 1999 - Downstream end (400 ft) repaired with rock. 2002 - New rock/concrete rubble section on the downstream end. 2004 - Small pocket repairs at the downstream end. 2005 - Some new bundles in the brush boxes. 2012 - Some rock has been placed in last year.

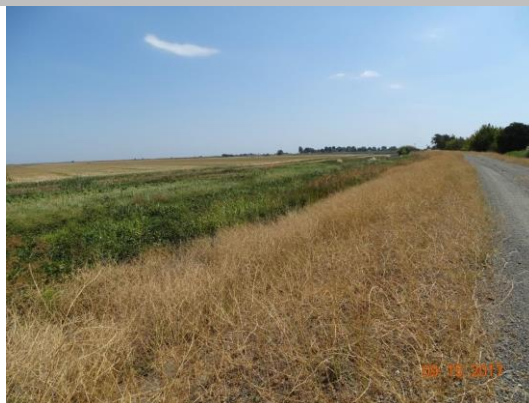
LM Start	11.01	Rating **	M	Issue No.	770
LM End	12.00	Issue Type +	Ma	Location *	LS
Category	Earthen Levee			GPS Latitude/Longitude	
				Start	End
Item	Vegetation			38.136623 °	38.130739 °
				-121.594216 °	-121.579678 °
DWR ID	DWR_RD0563_01_s_2015_770				
Comment Code					
V2 : Remove the wild growth other than native grasses from the levee slopes.					
Inspector Comment					
There is dense vegetation (wild roses) at the landside toe.

LM Start	11.01	Rating **	M	Issue No.	770 (cont)	
LM End	12.00	Issue Type +	Ma	Location *	LS	
Category	Earthen Levee			GPS Latitude/Longitude		
				Start		End
Item	Vegetation			38.136623 °		38.130739 °
				-121.594216 °		-121.579678 °
DWR ID	DWR_RD0563_01_s_2015_770					
Comment Code						
V2 : Remove the wild growth other than native grasses from the levee slopes.						
Inspector Comment						
There is dense vegetation (wild roses) at the landside toe.

Looking southeast at dense vegetation at landward toe. (Spring 2015)

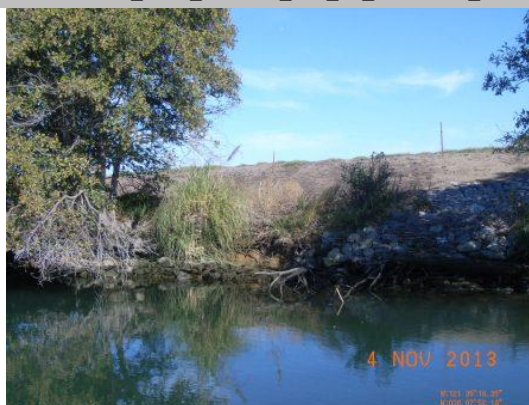
Photo 1 of 1 : SP\_2019\_RD0563\_210\_63\_20190311\_00022.jpg

LM Start	11.56	Rating **	M	Issue No.	63
LM End	11.66	Issue Type +	Ma	Location *	WS
Category	Supplemental			GPS Latitude/Longitude	
				Start	End
Item	2017 USACE Erosion Survey, DRAFT			38.130544 °	38.129968 °
				-121.587607 °	-121.585981 °
DWR ID	DWR_RD0563_01_f_2018_63

Comment Code					
Inspector Comment					
2017 Site ID: GEO 0.3 L					
Status: Eroding					
2017 Field Notes: Site shortened. New rock placed on levee slope in erosion pockets.					
Site History: 1997 - Erosion pockets into the levee toe. 1999 - Some small pockets fixed with rock riprap. 2002 - New "brush boxes" along the bank toe. 2005 - Brush boxes are empty. Some pockets are filled with new stone. 2006 - Some new rock at the downstream end (~100 ft long). Several small pockets of new rock in scallops. Brush boxes in poor to fair condition. 2010 - Site looks a little worse, some toe rock but still has erosion scars at lower to mid slope. 2011 - Site upgraded to CRITICAL. Significant new erosion. Erosion scallops are vertical and almost the height of the levee. 2012 - Rock has been placed in some of the erosion scallops and therefore the site is no longer critical. 2013 - Site shortened site. The downstream half of site was repaired by RD. Pipe no longer in site limits.

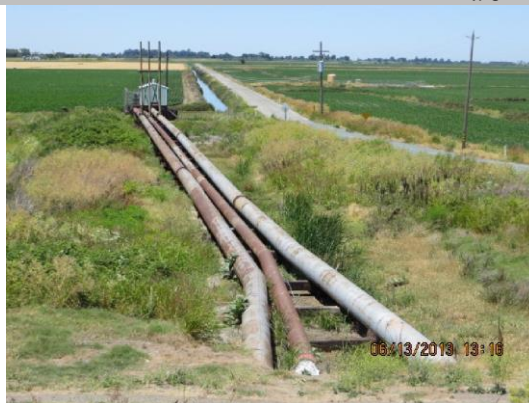
Photo 1 of 3 : UCIP\_SP\_2019\_52771\_24731.jpg

LM Start	12.00	Rating **	A/W	Issue No.	806
LM End	12.00	Issue Type +	Ma	Location *	
Category	Supplemental			GPS Latitude/Longitude	
				Start	End
Item	DWR UCIP LMA Responsibility		38.130726 °	38.130726 °	
			-121.579646 °	-121.579646 °	
DWR ID	20172				
Comment Code					
Inspector Comment					
FS_ID:52771 DS_ID:20172 EP_NO: 11213 Repair Type: No Action Needed Crossing Status: Found UCIP Comments: FIELD_STRUCT_DESC: 20-inch steel drainage pipe through the levee, 1 foot below the crown. Pump on the landside (LS). Siphon breaker on the waterside (WS) shoulder. (18-inch pipe [HLM 12.28] at a depth of 4-feet authorized under Automatic Board Order (ABO) issued as Permit No. 11213, 1975 - Reclamation District No. 563). [Additional Reference(s): DWR Levee Log, 2005. USACE Sacramento O&M Manual 103, June 1954, (Station ""L"" 6+48.9)]. FS Date: 7/13/2018

Pump and pipes off LS toe.
